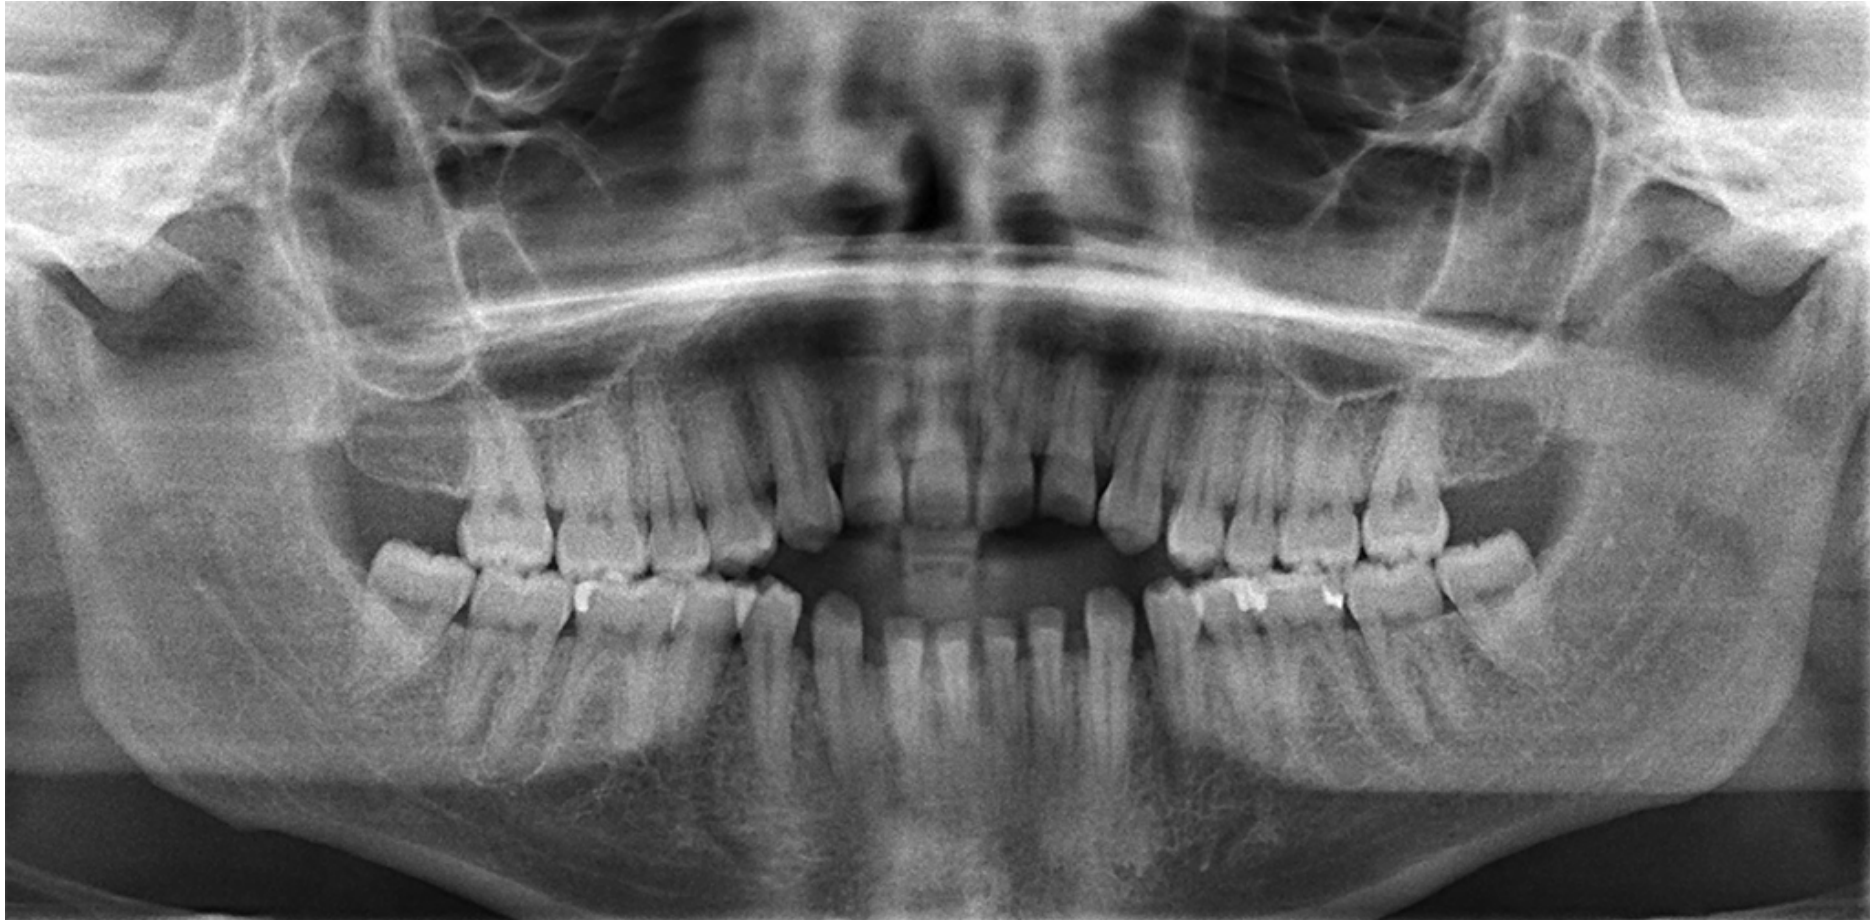
Figure 3: Pre-treatment panoramic radiograph. Panoramic radiograph showed a complete dentition except for the absence of both maxillary third molars. The bone level and density were within normal limits and the maxillary sinuses were clear. Asymmetrical short condyles revealed some degree of remodeling and asymmetrical position.
