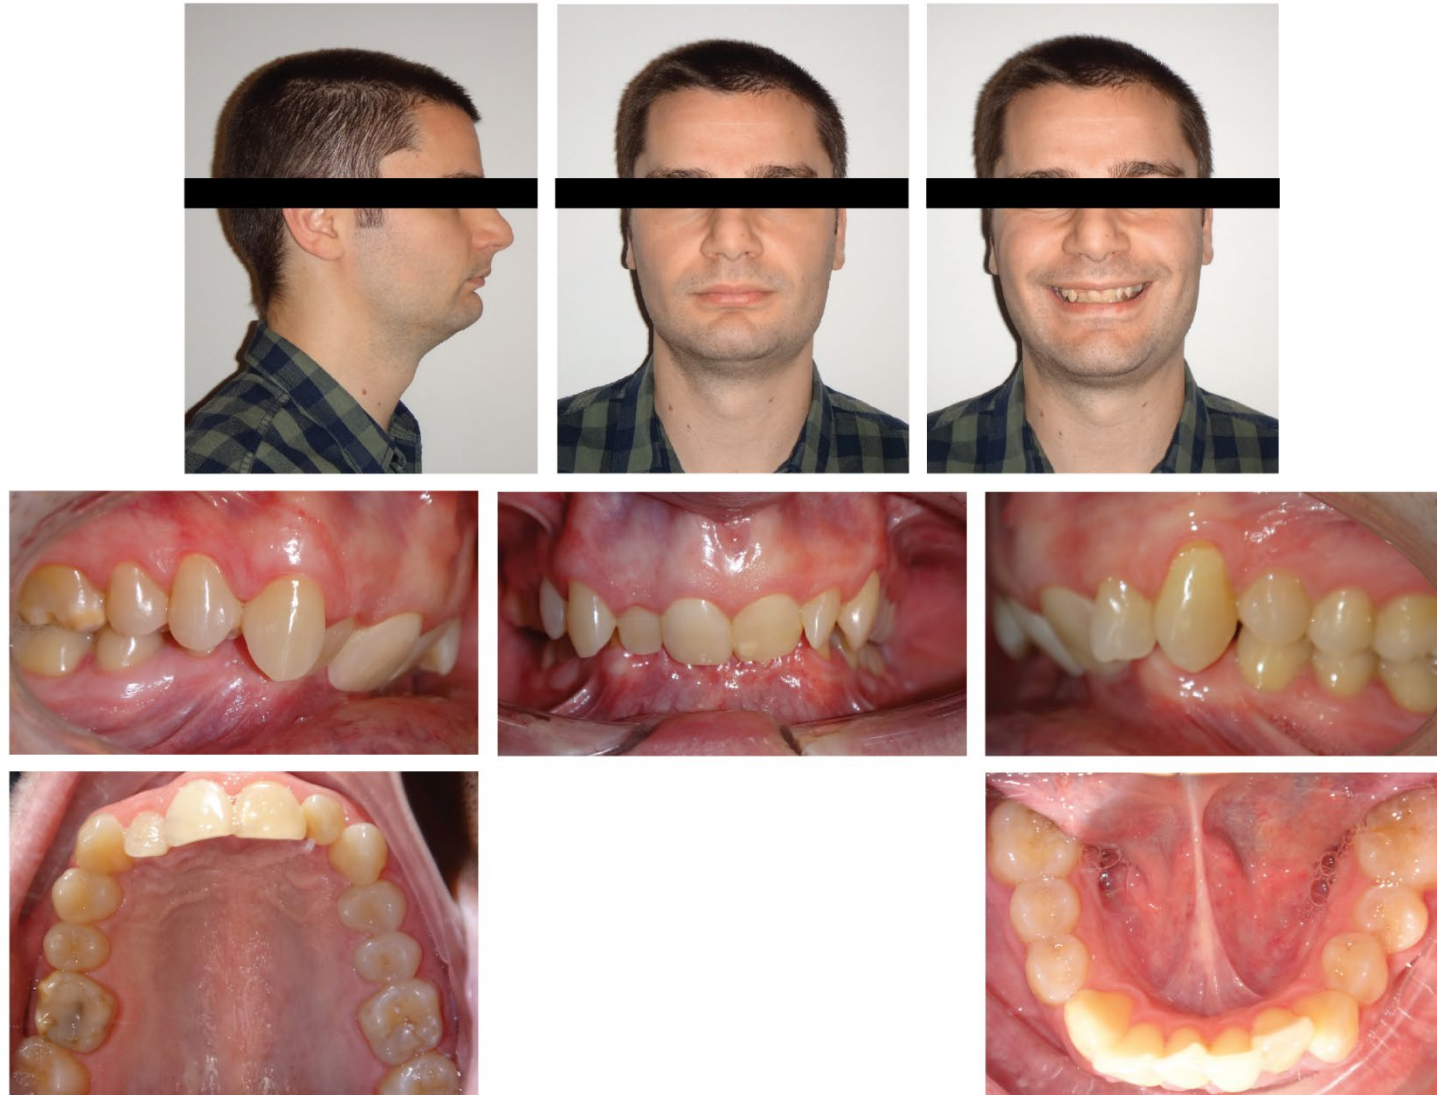
**Figure 1: Pre-treatment portrait and intra-oral photographs.** Lateral profile photograph shows a convex profile, a decrease in the mandibular facial third, a retrusive chin, and deficient maxillary and mandibular lip position. Frontal portrait photographs show large dark buccal corridors, 100% incisal display upon smiling, maxillary dental midline deviated 1.5 mm to the left in relation to the facial midline, mandibular midline coincident with facial midline upon opening. Intraoral photographs reveal a constricted maxilla and mandible, crowding in the maxillary and mandibular arches, severe deep bite, retroinclined maxillary anterior teeth, buccal crossbite at the maxillary right second molar, gingival recession on mandibular anterior teeth, and missing third molars.
