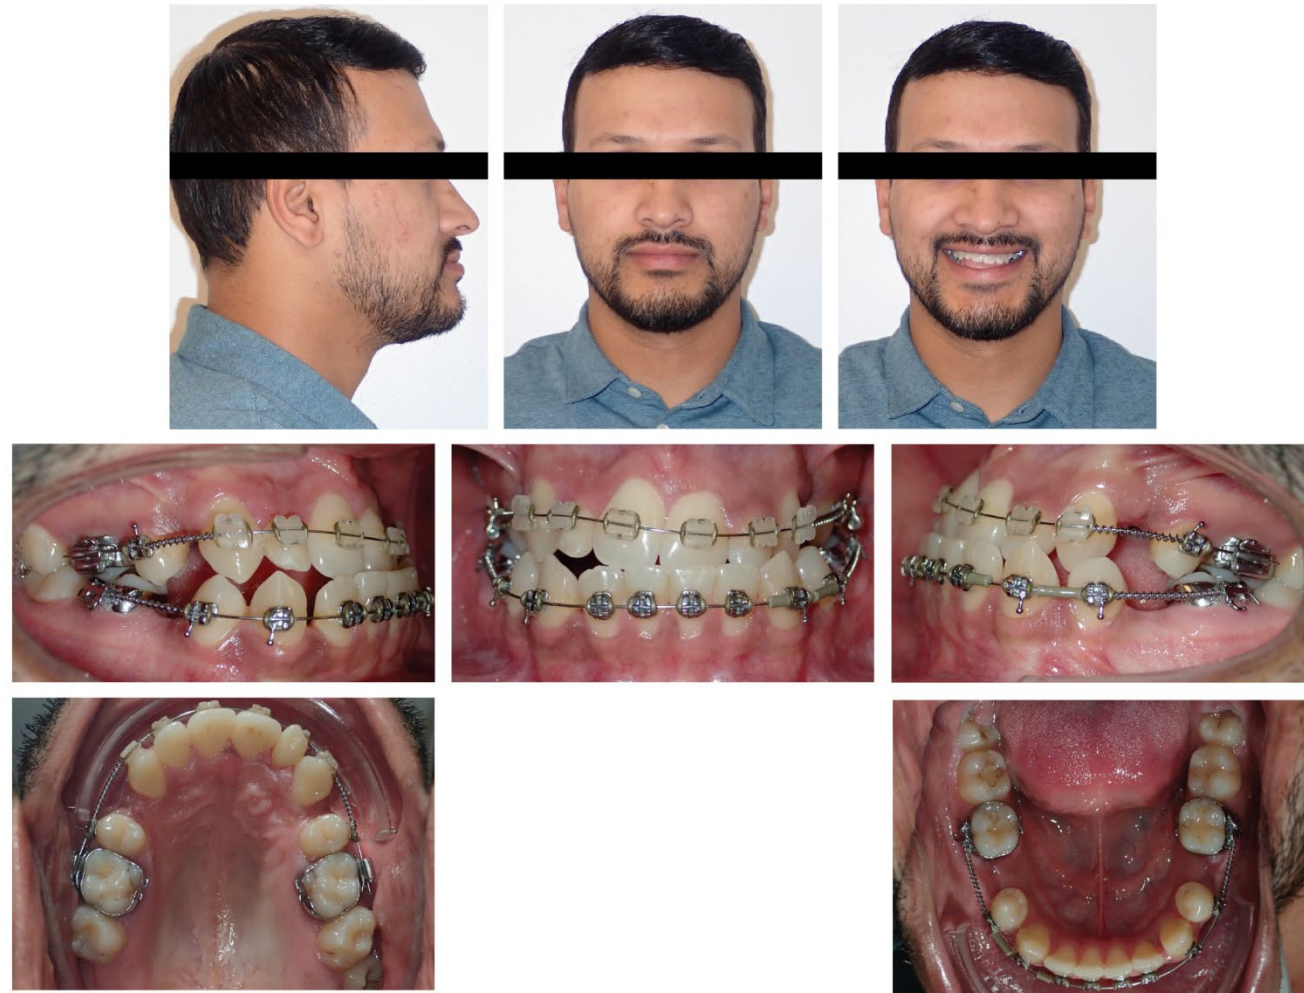
Figure 1: Pre-treatment portrait and intra-oral photographs. Adult male patient who was receiving orthodontic treatment (with fixed appliances shown in photos) in another clinic in preparation for orthognathic surgery. Patient was referred to CTOR clinics for possibility of non-surgical treatment. Lateral profile photograph showed a brachyfacial concave profile, a decrease in the mandibular facial third, a protrusive chin, and deficient maxillary lip and acceptable mandibular lip position. Frontal portrait photographs show dark buccal corridors, asymmetric incisal display upon smiling, maxillary dental midline deviated 3 mm to the right in relation to the facial midline, mandibular midline deviated 1.5 mm to the left with respect the maxillary dental midline. Measurements indicated a cant of the incisal plane elevated on the right side. Facial asymmetry noted as the mandible deviated to the right. Intraoral photographs reveal a constricted maxilla, spacing in area of maxillary first premolars and mandibular second premolars as they were previously extracted. A crossbite observed extending from the maxillary right premolar to left first premolar, and a Class III canine and molar relationship.
