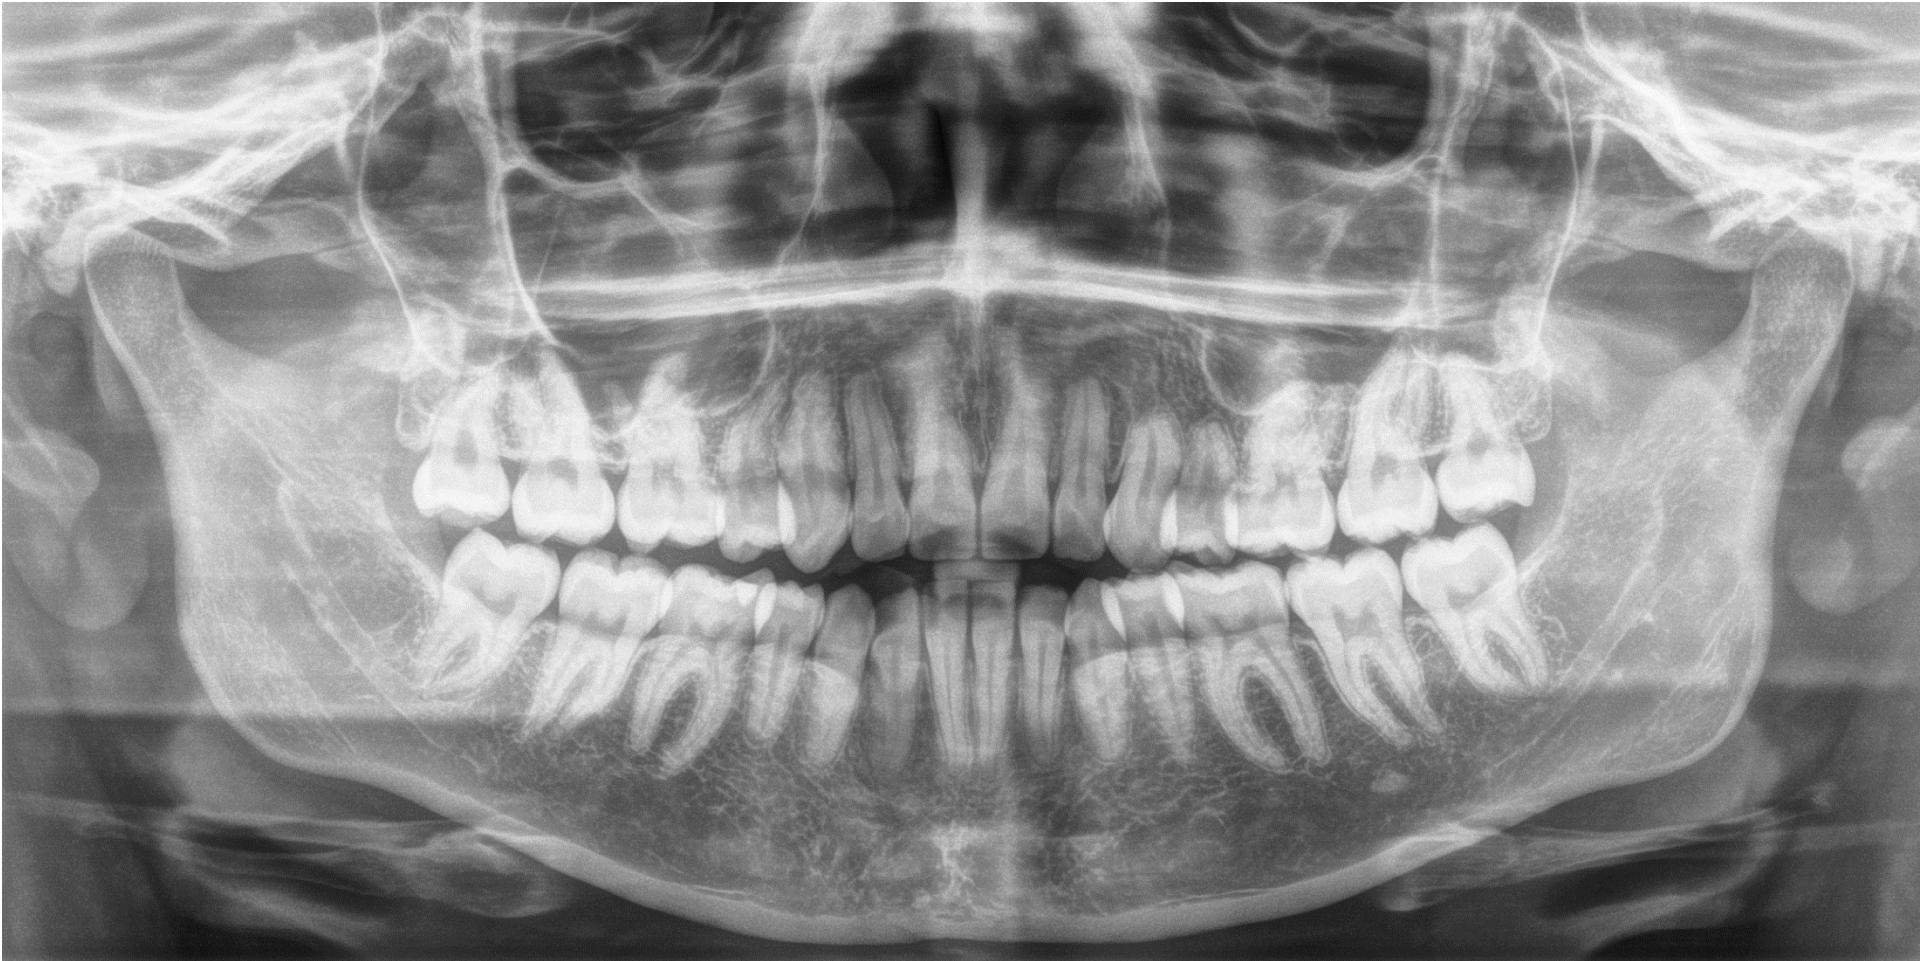
Figure 2: Pretreatment panoramic radiograph. Panoramic radiographs shows a complete dentition except for the absence of upper second and lower first premolars, spindle-like roots on molars, mild to severe root resorption of the maxillary central incisors, canines and premolar, and the lower right canine and premolar. Asymmetrical condyles show some degree of remodeling and asymmetrical position. Panoramic radiography showed an area of idiopathic sclerosis close to the root of the second left molar.
