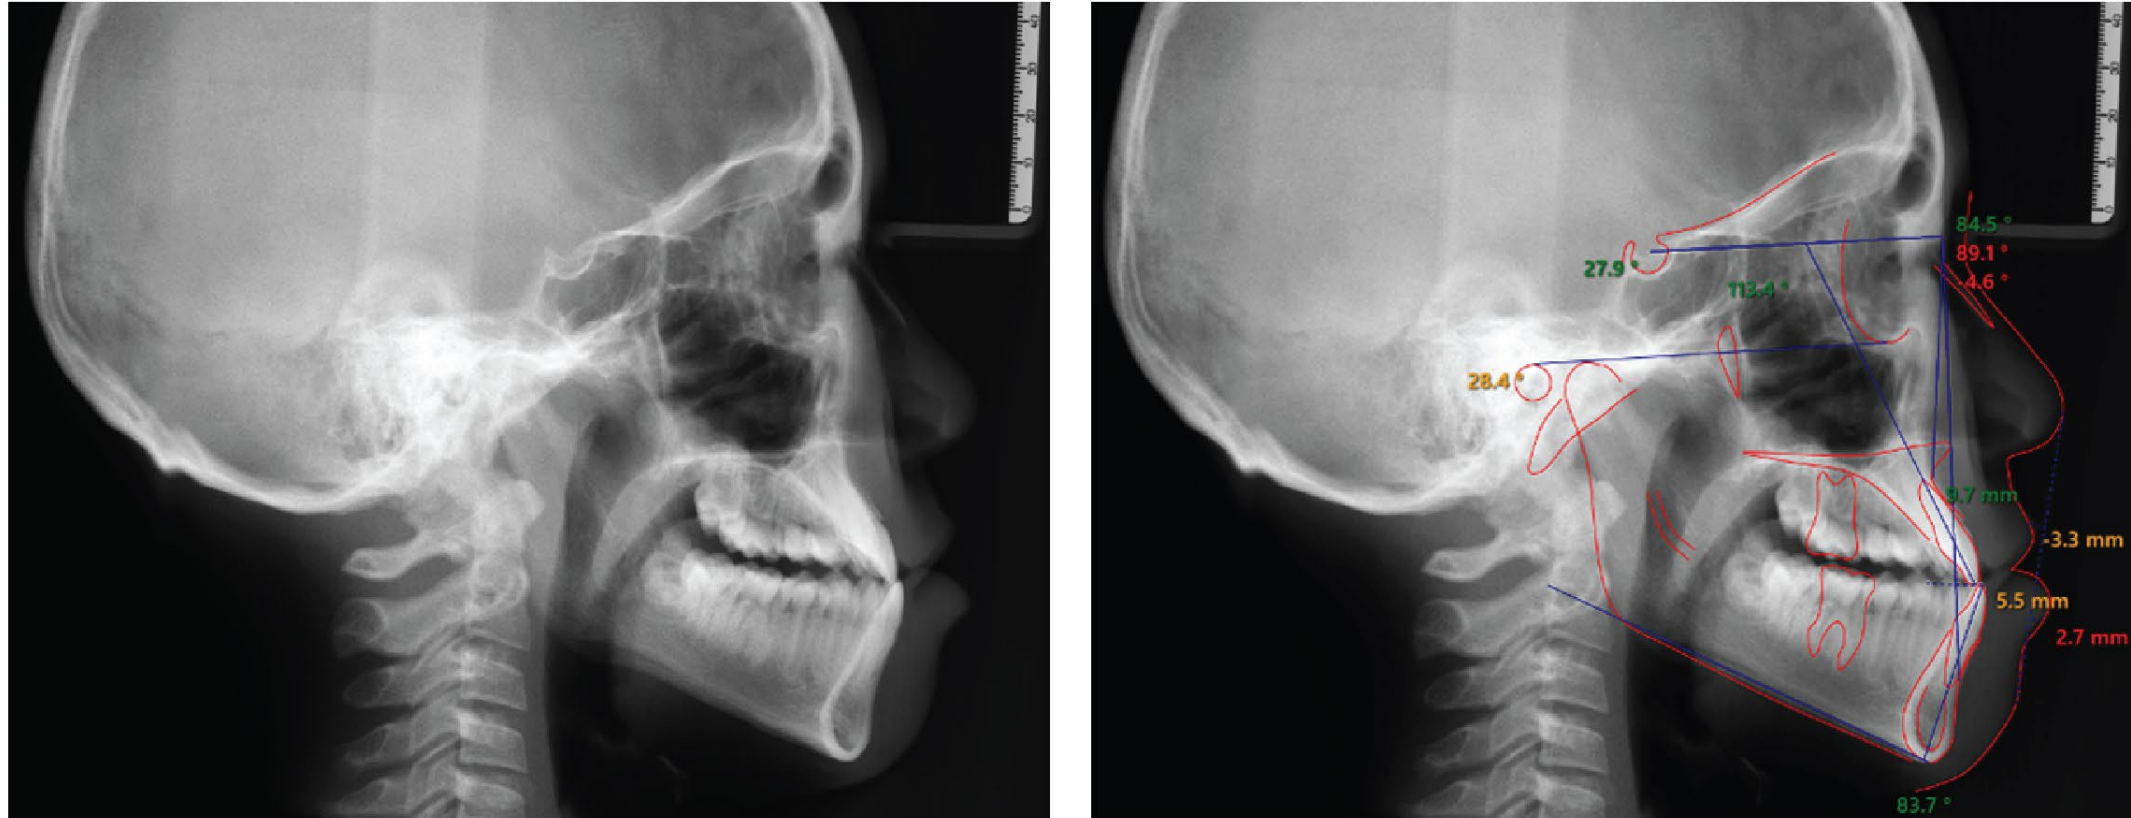
Figure 4: Pre-treatment lateral cephalometric radiograph and analysis. Cephalometric radiograph was taken with the patient posturing the mandible backwards into the first tooth contact position. Cephalometric analysis showed a hypodivergent mandible angle, a Class III skeletal relation, anterior crossbite with proclined maxillary incisors and normal inclination of the mandibular incisors.
